PRADS'98,  
Conference on Practical Design of Ships  
and Mobile Structures, Developments in  
Marine Technology, September 1998,  
The Hague, The Netherlands.

Report 1166-P, September 1998,  
Delft University of Technology,  
Ship Hydromechanics Laboratory,  
Mekelweg 2, 2628 CD Delft,  
The Netherlands.

## **Fatigue Damage in the Expansion Joints of SS ROTTERDAM**

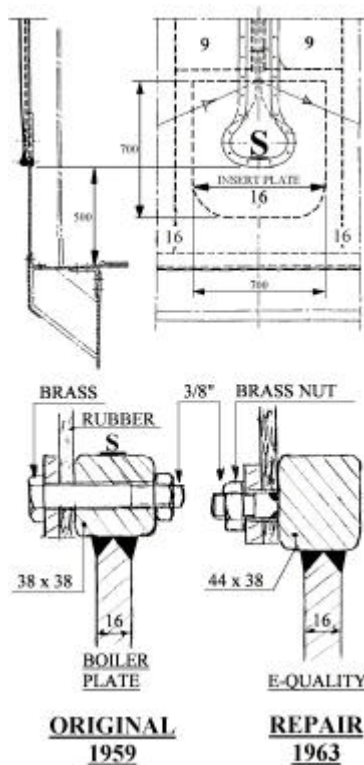
Figure 3 Expansion Joint Detail

Figure 3 shows a detail of the expansion joint as applied just above the promenade deck. Initially bolt holes were present in the edge strengthening bar. At the repair and modification in 1963 stud bolts were welded on the bar.

The major conclusion of the measurements was that there was only a slight increase in the stresses in the strength deck below the expansion joints. A stress concentration factor  $SCF = 4.4$  was found in the bottom of the joint (point S in Figure 3), which was higher than expected. It was realised that here the fracture strength of the steel 41 would be surpassed, as Lloyds set for this ship a maximum allowable hogging stress in the strength deck of 125 MPa. The section modulus at the strength deck, including owners extra's was 20

These factors, determined at the centre line of the expansion joint, do not include the effect of the presence of bolt holes.

The effect of the bolt holes in the strengthening bars in the expansion joints prove to be paramount with respect to fatigue damage.

1. The built in welding stresses were relieved by heavy loading of the hull.
2. The detail of the joint was improved deleting bolt holes.
3. The ship was taken out of the Trans-Atlantic service in 1969 where after she was mainly cruising in good weather areas.

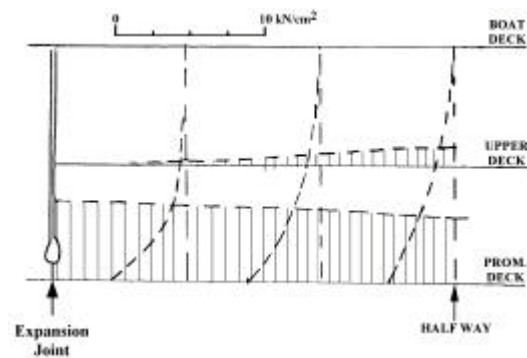
**Figure 8 Stresses in Promenade Deck and Superstructure Side**

During the launch of the vessel 1958 the Ship Structures Laboratory of the Delft University of Technology, DUT, and the Netherlands Organisation of Applied Scientific Research, TNO, carried out strain measurements on several spots in the vessel [12]. The bottom of the expansion joint and the promenade deck were included. Stresses during launching were 40% of the stresses calculated for the design wave (see Figure 8).

It is noted that the *SCF*'s do not match very well. The effect of mesh size was checked but proved in this case negligible. The effect of the stress built up between the expansion joint (Figure 8) proved to contribute substantially to the stress increase in the joint.

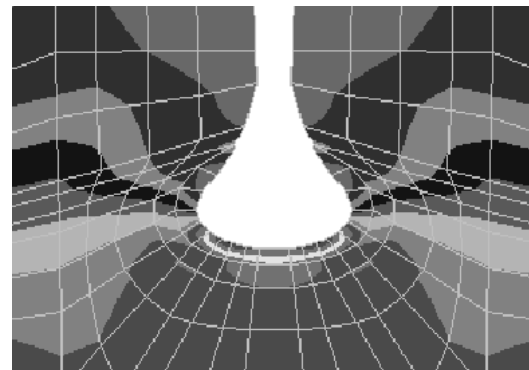
**Figure 9 Stress Contour in Way of Expansion Joint (Frame 137-138), Coarse Mesh.**

The stress increase between lower edge (deck level) and the bottom of the joint was similar in both cases:  $SCF = 2.7$ .

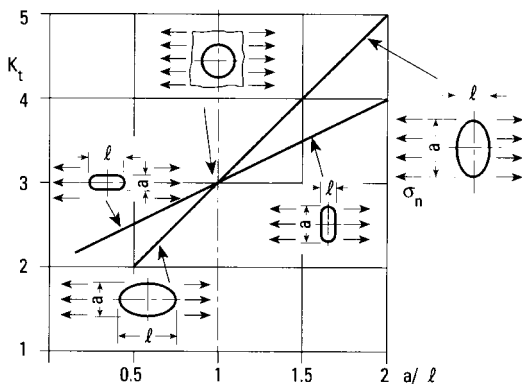
**Figure 10 SCF for Cut Outs From [10]**

In case of the presence of bolt holes an additional *SCF* must be applied of 3, see Figure 10 obtained from ref. [10].

Therefore the actual *SCF* to be used in a fatigue assessment should lie between 5.1 and 13.2!

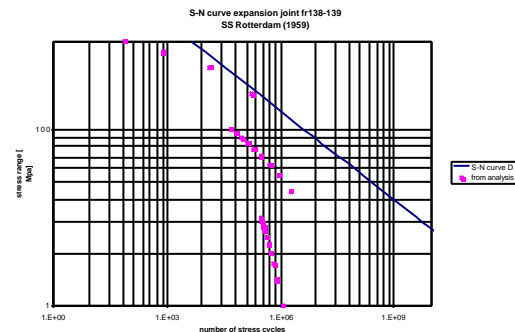
**Figure 11 Stress Level Versus Number of Stress Cycles (S-N Curve)**

Without applying any *SCF* the result is shown in Figure 11. This diagram is valid for the stresses in the promenade deck. From [11] an S-N curve (curve D) has been taken, considered to be valid for the structural detail under consideration. This curve shows the number of stress cycles “required” to obtain fatigue damage at any stress level.
