PRADS'98,  
Conference on Practical Design of Ships  
and Mobile Structures, Developments in  
Marine Technology, September 1998,  
The Hague, The Netherlands.

Report 1166-P, September 1998,  
Delft University of Technology,  
Ship Hydromechanics Laboratory,  
Mekelweg 2, 2628 CD Delft,  
The Netherlands.

## **Fatigue Damage in the Expansion Joints of SS ROTTERDAM**

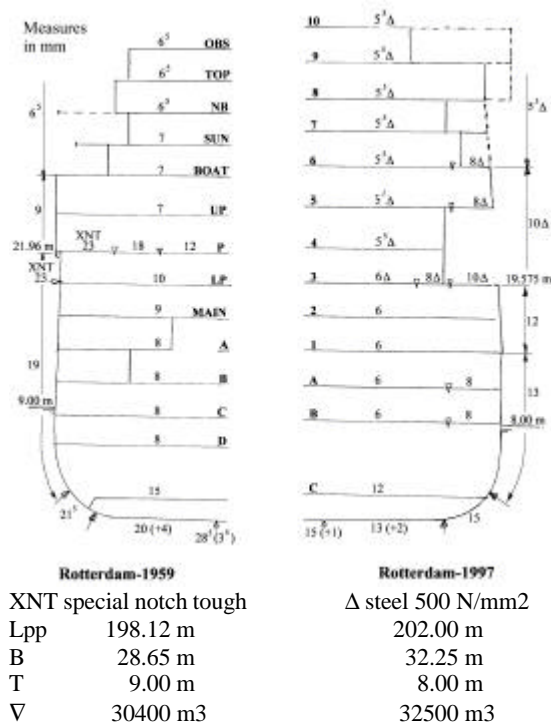
Figure 2 Cross-Section ROTTERDAM 1959/1997

Figure 1 shows a side view of the ship and Figure 2 gives a general impression of the midship section. For comparison the cross section of the new ROTTERDAM-1997, built in Italy, is shown as well. The 1959 ship has the promenade deck (P) as strength deck. The plating of the 1997 ship on deck 3 and above is of high tensile steel, while the superstructure up to deck 8 forms part of the hull girder. It is remarkable to see that plate thicknesses have been reduced considerably over the years. The ROTTERDAM-1959 is fitted with transverse frames, while the ROTTERDAM-1997 is fitted with high

tensile longitudinal frames. Owners extra's are indicated in brackets. Both ships are classified by Lloyds Register of Shipping. The sectional modulus of ROTTERDAM-1997 at deck 8 (34.80 m above base) is almost equal to the section modulus of ROTTERDAM-1959 at the promenade deck P (21.96 m above base).

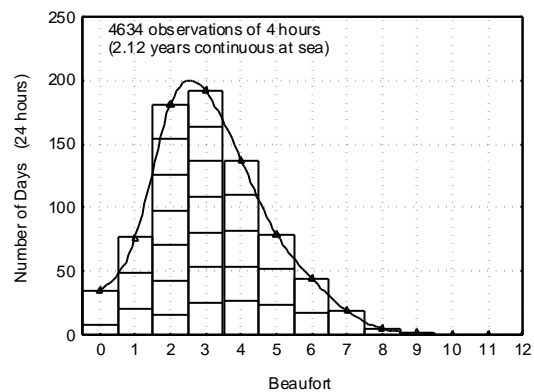
Figure 6 Exposure of Vessel to Sea States From 1959 Till 1963

The data from the logbooks were taken per sea watch, i.e. 4 hours. The time span investigated starts in September 1959 and continues until April 1963. In total 4634 observations were recorded. Figure 6 shows the exposure of the vessel to sea states during the considered period.

It can be seen that the vessel has not often been subjected to very heavy weather. For each period a Bretschneider sea spectrum is assumed based on the observed sea state. From this spectrum and the heading of the ship, the horizontal and vertical bending moment in the ship's hull in way of the expansion joint were calculated. Because of the closed cross section, torsion could be ignored. Next, they were divided by the respective section moduli and added, thus yielding a spectrum of longitudinal stresses in the promenade deck at the side. As illustration, Figure 7 is included to give an impression of stresses in the promenade deck.

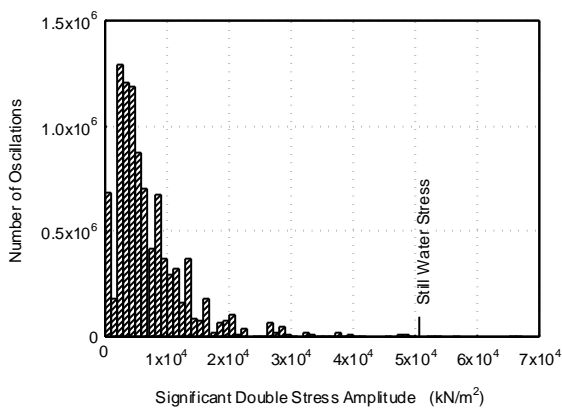
**Figure 7 Stress Levels Versus Number of Stresses in the Promenade Deck**

The area properties  $m_{0s}$  and  $m_{2s}$  of the stress spectra were used as input for the fatigue analysis.
